Damage reconnaissance and seismic response prediction of an East Coast U.S. building subjected to 2011 Virginia Earthquake

During the 2011 Mineral, Virginia Earthquake the Smithsonian Institute Museum Support Center (MSC) sustained considerable structural damage. An in-depth study was conducted to investigate the behavior of MSC during this earthquake and its potential implication on seismic risk of East Coast U.S. structures. The damage sustained by this building is documented and it is observed that the severity of damage is not uniformly distributed in the floor plan. A finite element model is created to perform the seismic response prediction using recorded ground motions in order to explain the cause of structural damage. A field vibration test was conducted to capture the dynamic characteristics of the building which are in turn used to calibrate the finite element model. Results from seismic analysis reveal that the main reason for seismic damage is local soil amplification and combined torsional and translational effects due to an eccentric floor mass distribution relative to the center of rigidity (CR) of the floor plan.

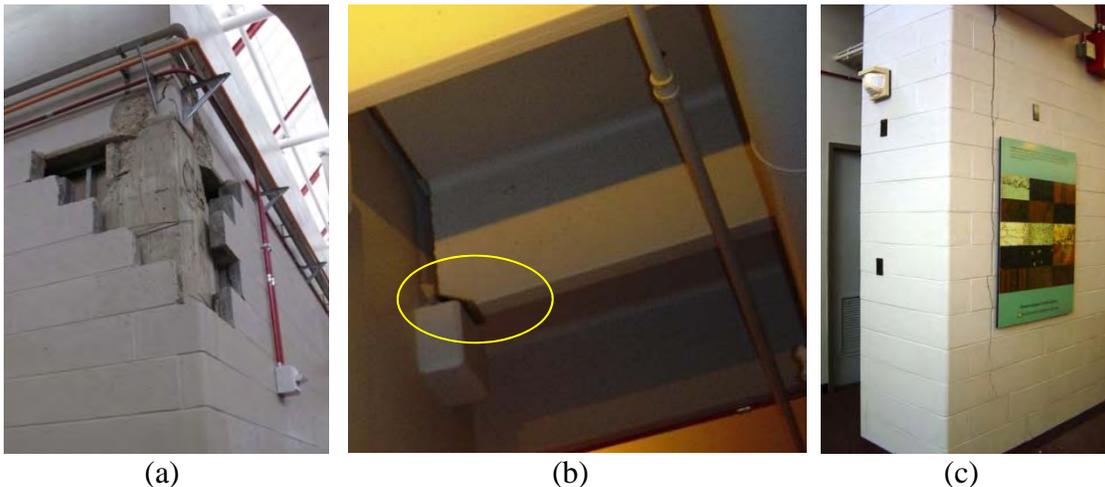
The 2011 Virginia Earthquake caused extensive damage to both the concrete and steel frames of the MSC. The typical damage in the concrete structures includes concrete spalling, and cracking in the masonry wall and T-beam sliding (see Figure 3). Figure 3a shows a RC beam-column joint failure which is located in the corner of Office 1. In this specific failure, concrete at the ends of the beam and columns adjacent to the joint have spalled; the rebar has buckled; and the tile at the upper half of the corner has fallen off. Figure 3(b) shows a 2-inch sliding of a precast roof T-beam from its support bearing. Figure 3(c) shows a crack of about $\frac{1}{4}$ " wide over the entire height of the masonry wall.

Figure 3. Representative damage in concrete and masonry structure: (a) RC beam-column joint failure; (b) sliding of reinforced concrete T-beam at roof; (c) cracking of CMU wall

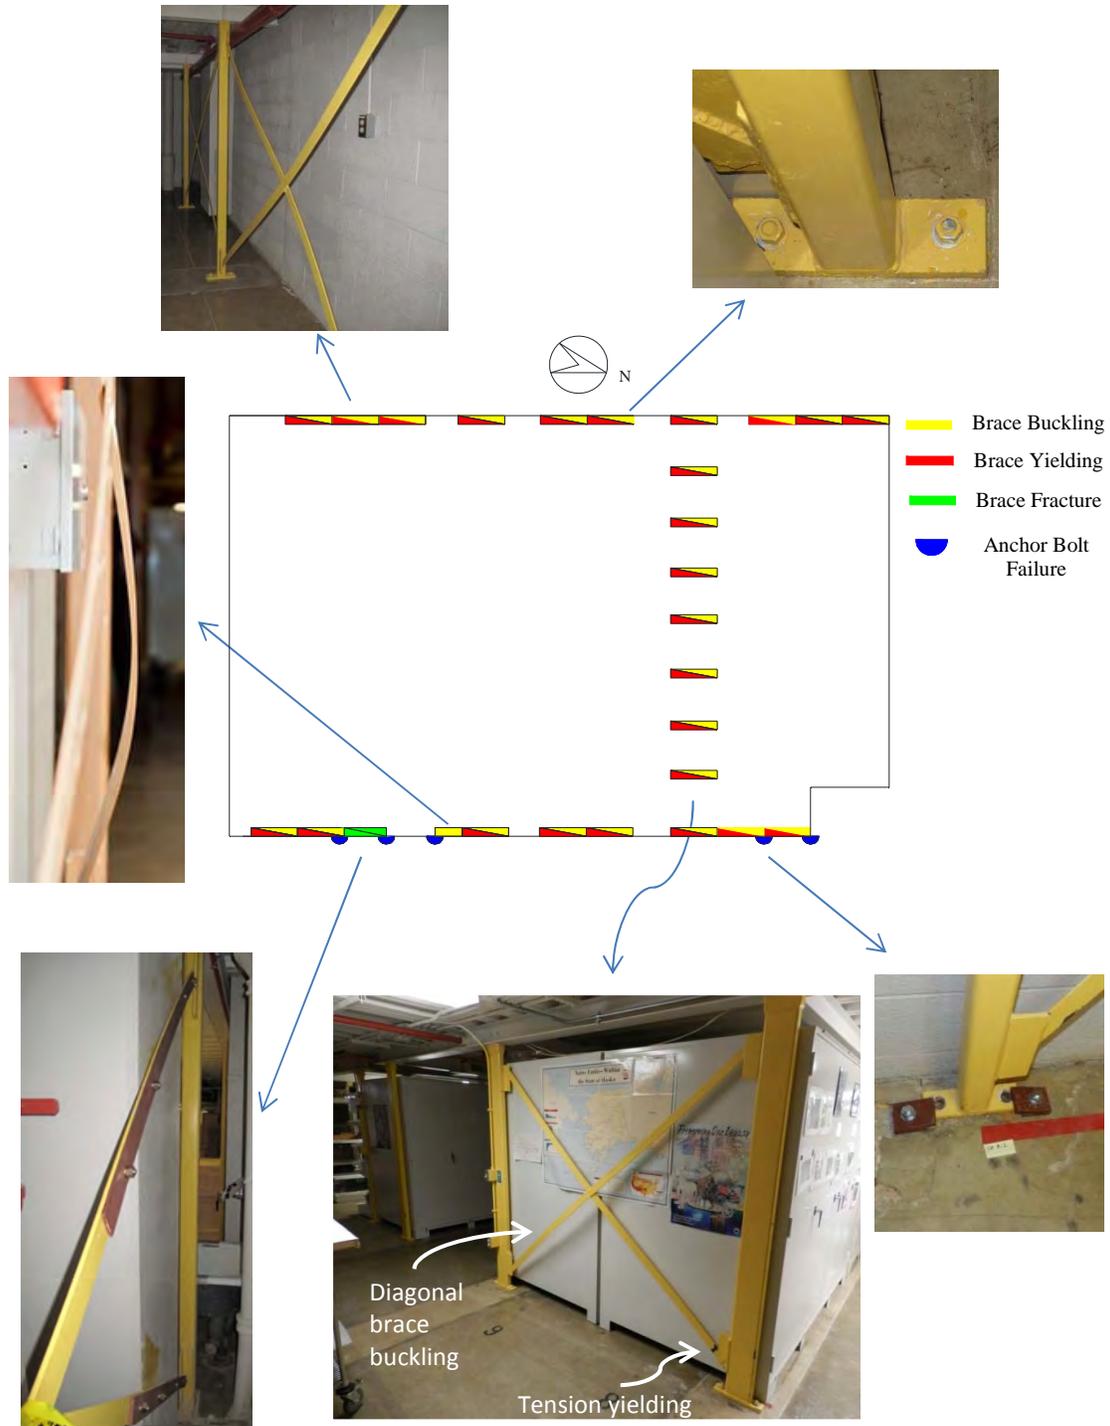
Typical damage developed in the steel structure consisted of buckling, yielding and fracture of the diagonal bracing in both stories as well as column base plate anchor bolt failure at the ground floor. According to observations, the mezzanine in Pod1

suffered the most severe damage amongst all Pods. Damage occurred in both stories of the mezzanine but was more severe in the first story. The second story only suffered from some minor yielding and buckling. The condition and the locations of damage in the first story are illustrated in Figure 4.

Figure 4. Type and distribution of damage in the first story of steel mezzanine in Pod 1

1. The damage is associated with the diagonal bracing. Only the braces in the framing system were damaged and there is no observed damage in the beams or columns. Only the column base plate anchor bolts in the braced bays at the ground level are damaged.

2. Brace damage occurs only in the long direction of the floor plan of the mezzanine while those in the short direction remain intact.
3. Severity of damage is not uniformly distributed throughout the floor plan of the structure: the east perimeter of the structure is more seriously damaged. The extent of yielding or buckling of the diagonal braces in the east perimeter of the structure is more severe than that along the west perimeter. Moreover, in one braced bay along the east perimeter both of the cross bracing fractured at the first story. In addition, several column base plate anchor bolt failures occurred in the braced bays along the east perimeter while the anchor bolts in the west perimeters show no sign of damage.

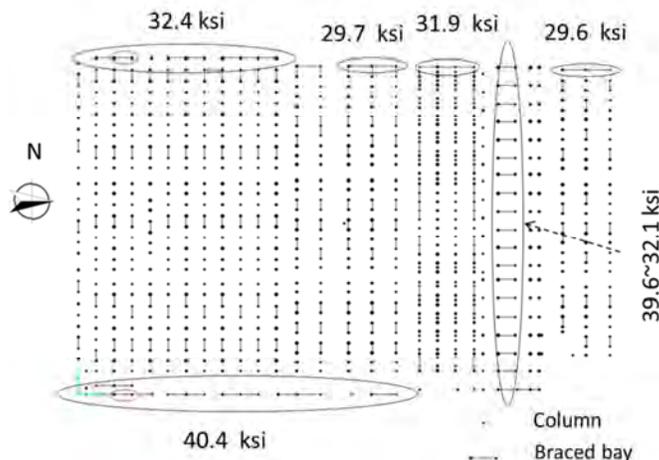
Figure 10. Peak axial stress response in 1st story braces, Case I

Figure 10 shows the peak axial tensile stress in the diagonal braces. The peak response is in the braces along the east perimeter, where the stress is as high as 40.4 ksi, exceeding the nominal yield stress of the 36 ksi (A36 steel). In comparison, the response of the diagonal braces along the west perimeter is smaller than their counterparts in the east perimeter. This is consistent with the observed damage pattern (Figure 4) in which the east perimeter of the structure suffered more damage than the west side.

By close examination, this unique damage pattern can be attributed to significant coupling between the translational and torsional displacement of the floor diaphragm induced by bi-directional ground motion excitation. The effect of bi-directional excitation is clearly demonstrated by comparing the response of the structure under uni-directional and bi-directional ground motion. Figure 11 presents the time-history of lateral displacement in the NS direction for two braced bays located respectively at the east and west perimeter (identified within the red circles in Figure 10) under uni-directional ground motion in the NS, EW and bi-directional ground motion, respectively. When the ground motion strikes in the EW direction (i.e., short direction of the building; Figure 11(b)), the displacement demand in the NS (i.e., long direction of the building) direction is comparable to the case when the building is subjected to ground motion in the NS direction (Figure 11(a)). In addition, the non-uniform response in braces in the long direction of the building is also caused by ground motion in the short direction of the building. The reason is, in this case, the CR of the first floor deviates from the CM by 13.9' to the south and 1.2' to the east (see Table 2). Larger eccentricity in the long direction creates a significant component of torsion in the second and third modes (Figure 13). In addition, the earthquake in the short
