The Geological Society of America
Special Paper 509
2015

Behavior and damage of the Washington Monument during the 2011 Mineral, Virginia, earthquake

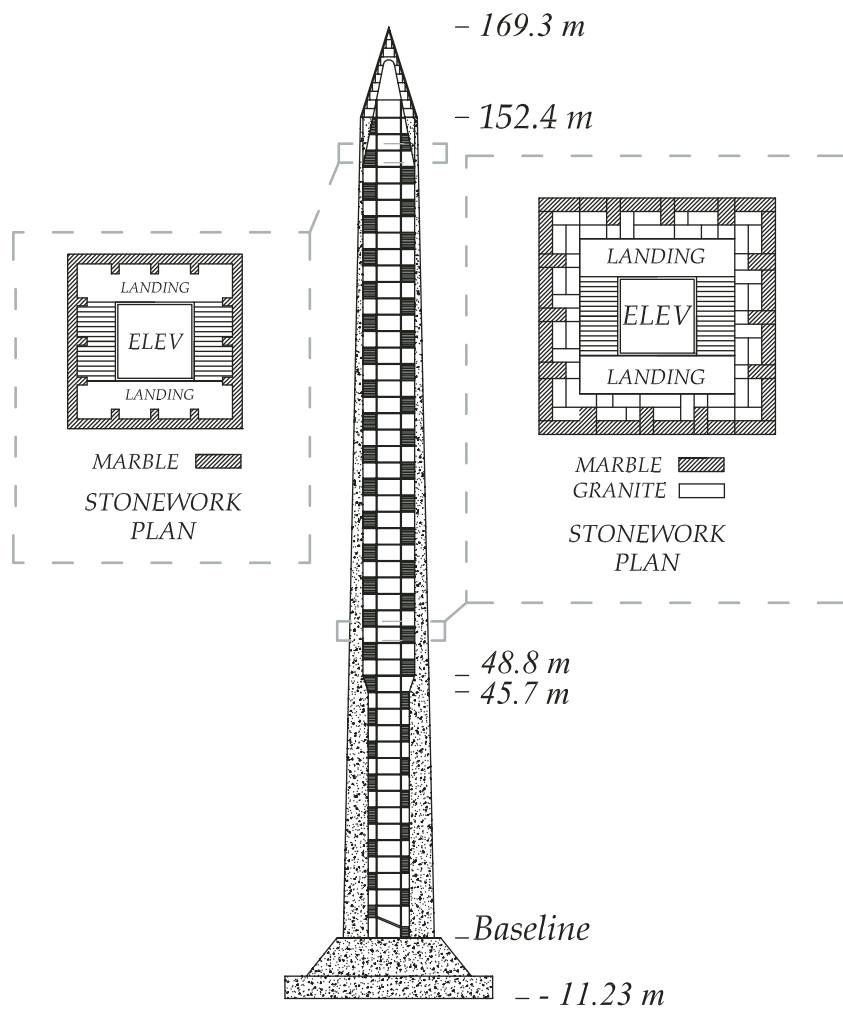
The masonry shaft of the WAMO (shown in Fig. 1) can be divided into four basic sections. The first section consists of walls made of marble and bluestone that extend vertically from a stair-stepped pyramid foundation made of blue gneiss. This section was constructed in 1848 after the establishment of the National Monument Society, which solicited public funding for the construction of the monument. Due to setbacks in securing funding and the onset of the Civil War, construction was halted for more than two decades. At this point, the construction of the WAMO was given to the U.S. Army Corps of Engineers. A study done by Colonel Thomas L. Casey at the time indicated that the original foundation would not be sufficient to support the massive weight of the WAMO (John Milner Associates, Inc., 2004). Therefore, the foundation was redesigned and strengthened using a system of tunneling and filling with concrete. The new foundation, with a base 38.5 m long at each side and a depth of 11.2 m, fully encased the primary foundation in concrete (John Milner Associates, Inc., 2004). Casey based the new design of the masonry shaft of the WAMO on architectural concepts of the Egyptian obelisks. Therefore, in the final design, the outer walls are tapered by 0.64 cm per 30.5 cm (Historic American Engineering Record, 1986) and the WAMO is 169.3 m tall, including its pyramidion; the height of the structure is approximately 10 times its baseline dimension of 16.9 m. The second section of the monument, from elevation 45.7 m to 48.8 m, was built when construction resumed after the final designs were completed. This section is important because within it the inner walls are not vertical and the inner dimensions of the structure change from 7.6 m to 9.6 m. The third section of the WAMO extends from 48.8 m to 152.4 m just below the pyramidion. This section is similar to the first section, the changes being the dimensions and thickness of the walls and the type of stone used in their construction (marble and granite below the 137.2 m level, and marble from the 137.2 m to 152.4 m level). The fourth section of the WAMO is the pyramidion, from 152.4 m to 169.3 m. An aluminum cap is at the tip of the pyramidion to protect the stone from weathering.

Figure 1. East elevation and section views of the Washington Monument.

As shown in Figure 1, the outer walls of the WAMO are constructed from a combination of marble and granite. Therefore, in the model, an average of the material properties of these two types of stone was used. Table 1 shows the range of values for the modulus of elasticity and unit weight of granite, marble, and iron; 45 GPa and 85 GPa were used as lower and upper bounds of the modulus of elasticity of the stone and 25.9 kN/m³ for its unit weight. The material model for iron was defined using 190 GPa and 210 GPa as lower and upper bound values, and 76.2 kN/m³ unit weight.

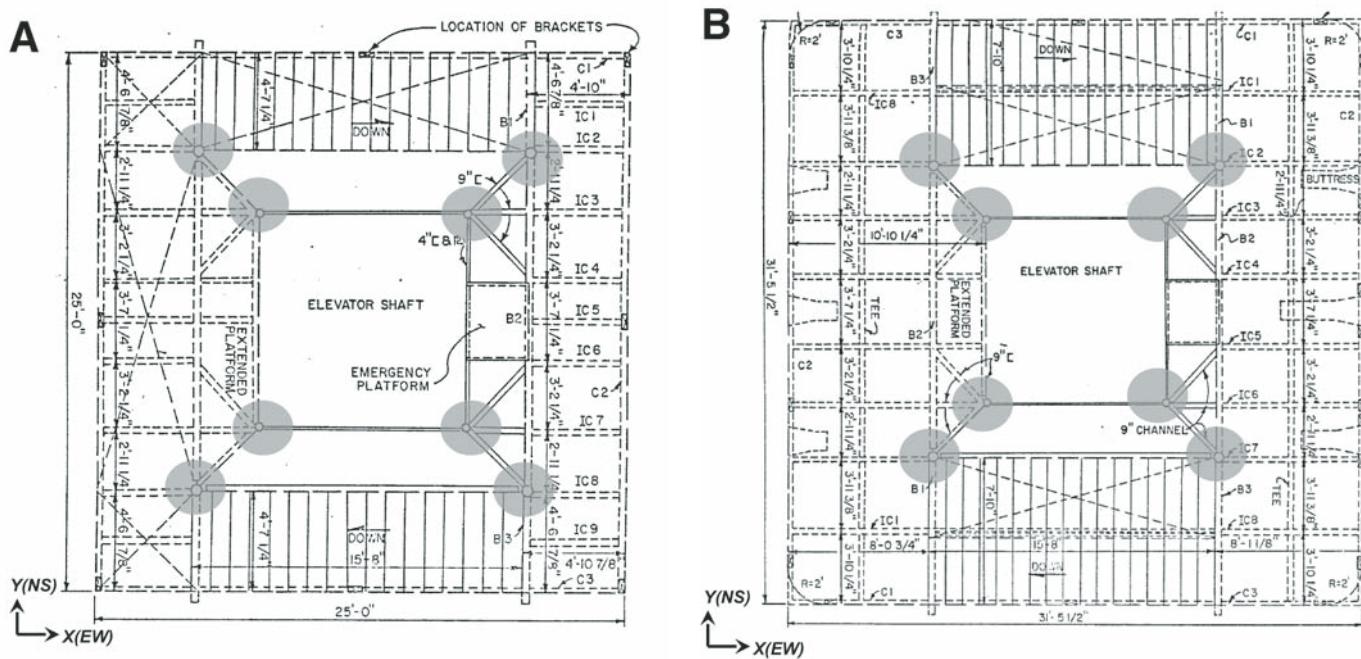
This historic blueprint was also able to provide some information regarding the inner structure of the monument. Horizontal platforms and staircases that are shown in Figure 1 are located at every 3.05 m along the height of the structure. Vertical columns support the platforms, staircase, and an elevator shaft which is in the center of the monument. More detailed blueprints of the interior structure are available through the National Park Service (Oehrlein and Associates Architects, 1993). Shown in Figure 2 are interior sections of the WAMO at 45.7 m and 48.8 m levels. This figure shows that there are eight columns (circled in Fig. 2) extending vertically over the height

Figure 2. Detailed interior structure of the Washington Monument. (A) 150 ft (45.7 m) level and (B) 160 ft (48.8 m) level (Oehrlein and Associates Architects, 1993) Note: Gray circles represent vertical iron Phoenix columns and $25' = 7.6 \text{ m}$ and $31' - 5 \frac{1}{2}'' = 9.6 \text{ m}$.

of the structure; these are Phoenix columns (an innovation of the Phoenix Iron Works, Phoenixville, Pennsylvania), each a circular pipe column made of iron, commonly used during the time of this construction.

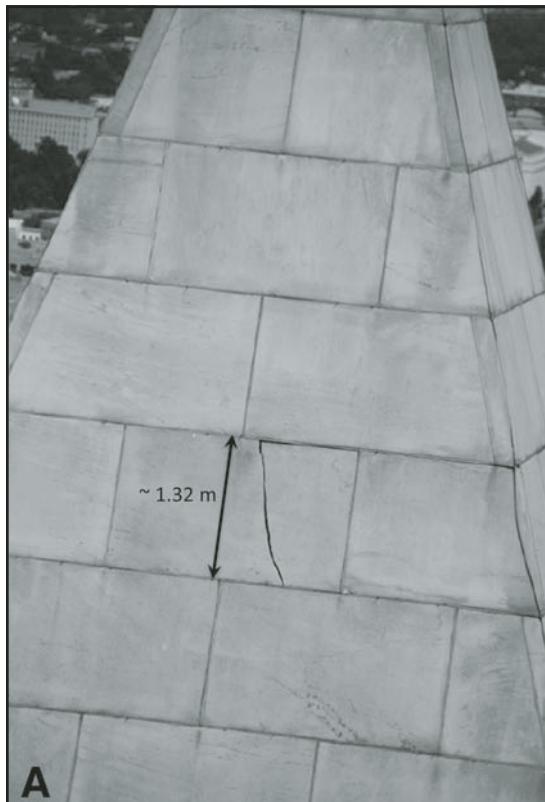
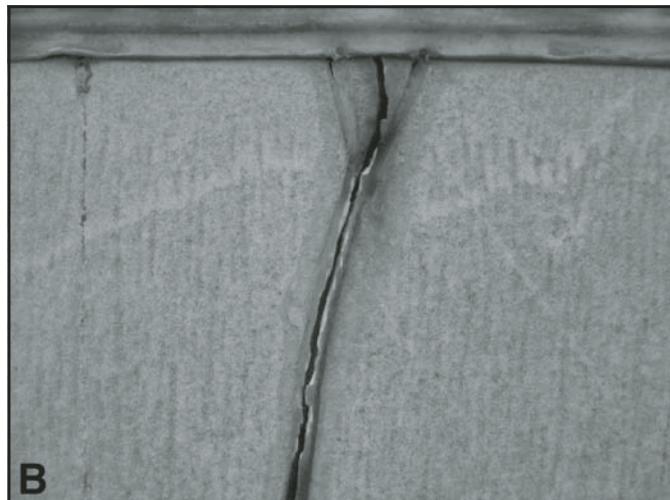
The WAMO was damaged during the 2011 Virginia earthquake, causing it to be closed to the public until repairs could be completed (May 2014). The main types of damage observed in the WAMO were cracking and spalling of the exterior stone. Cracking and spalling occurred over the entire height of the structure; a larger density of cracking occurred in the pyramidion as well as the upper section of the shaft around the 137.2 m level. Figure 3 shows examples of cracking in the marble pyramidion panels. The crack shown in Figure 3A is 1.32 m in length and 18 cm deep, and cuts through the entire depth of the marble panel. Figure 3B shows a close-up view of cracking of a previously repaired crack in a pyramidion panel.

Figure 3. Cracking in pyramidion of the Washington Monument. (A) A newly developed crack on the west face of the pyramidion (B) Additional cracking along a historic crack (Wiss, Janney, Elstner Associates, Inc., 2011).

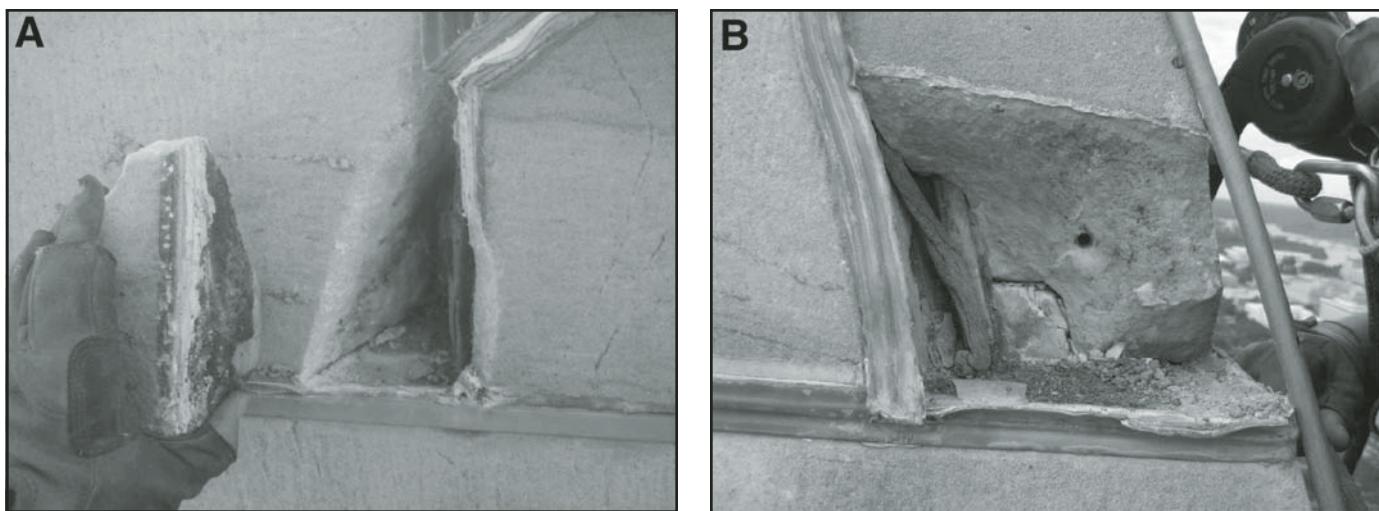
Examples of the observed spalling are provided in Figure 4, including spalling of the corner of a marble pyramidion panel and a complex spall at a previously repaired corner.

Figure 4. Spalling of pyramidion panels of the Washington Monument. (A) North face. (B) Northeast corner (Wiss, Janney, Elstner Associates, Inc., 2011).

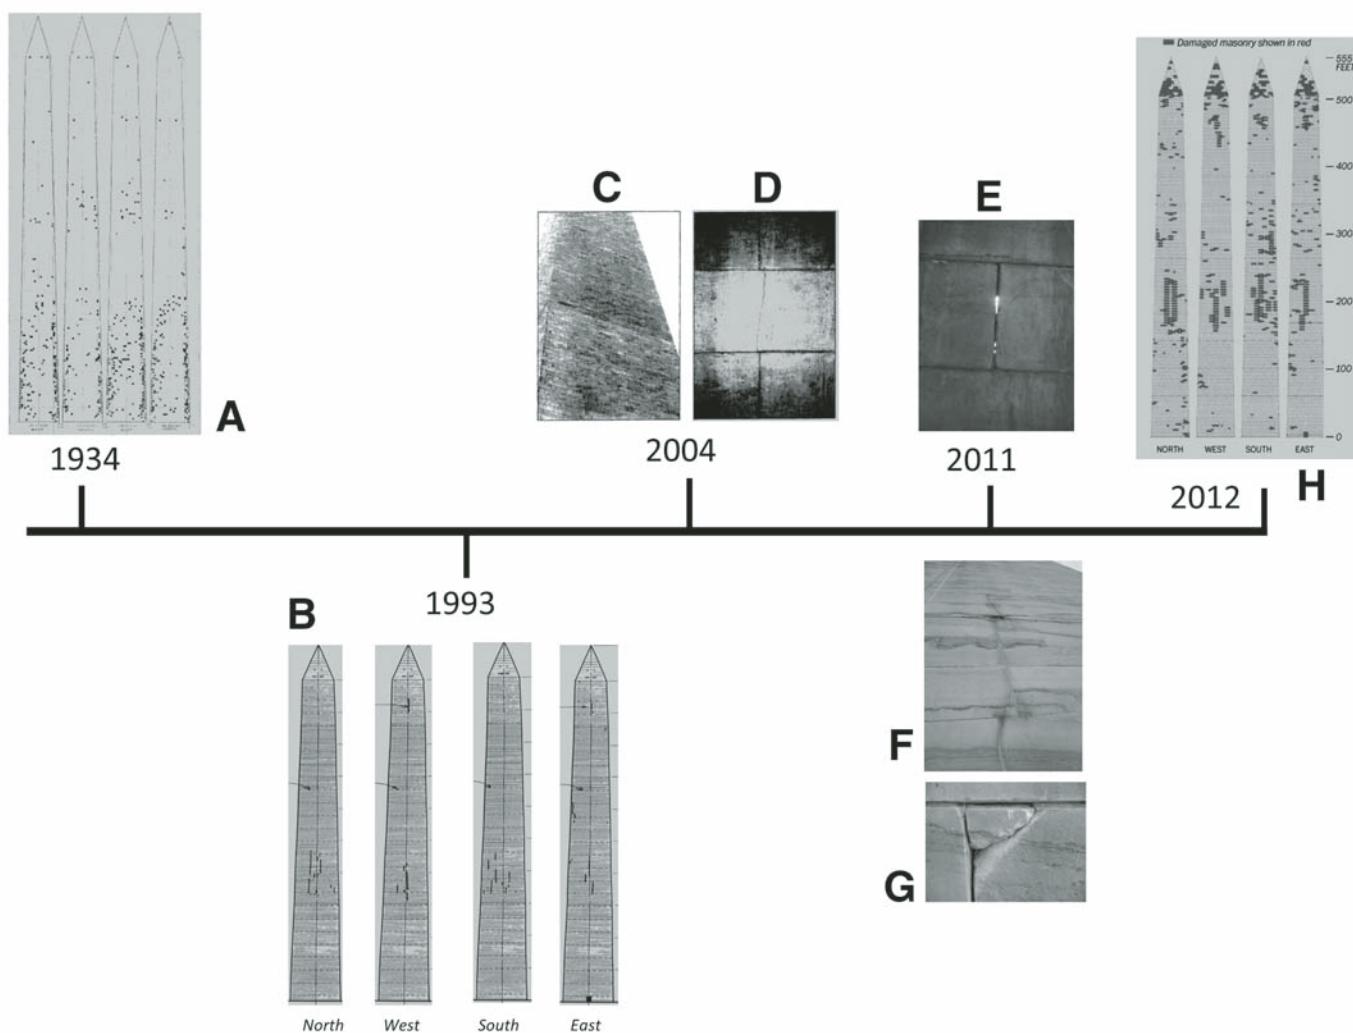
essarily occur during the 2011 Virginia earthquake. In order to investigate this issue, Figure 5 presents a timeline of the documented condition surveys of the WAMO. Figure 5A shows the condition of the exterior stones of the WAMO in 1934 (John Milner Associates, Inc., 2004); where the spalling was more severe below the 45.7 m level of the shaft. Figure 5B displays the results of a crack survey on the exterior of the WAMO published in 1993, which shows two main categories of cracking on all faces of the monument: (1) lower level cracks, between the 48.8 m and 71.3 m levels, and (2) the upper level cracks, above the 137.2 m level (Oehrlein and Associates Architects, 1993). Figures 5C and 5D respectively, show vertical cracking above the 45.7 m level (west elevation) and 128 m level (inside) the monument, documented in 2004 (John Milner Associates, Inc., 2004). Figures 5E–5G are from the post-earthquake assessment of the WAMO performed by Wiss, Janney, Elstner Associates, Inc. (2011), and show the loss of mortar in a vertical joint above the 137.2 m level, the cracking of a previously repaired vertical joint on the west elevation, and deep spalling on the west elevation near the pyramidion. Figure 5H, published in *The Washington Post* (9 July 2012), shows the damaged masonry stones of the WAMO on its four elevations. These observations from the timeline imply that the 2011 Virginia earthquake-induced damage on the WAMO is most likely on the pyramidion and upper and middle levels of the masonry shaft.

Figure 5. Timeline of the Washington Monument condition survey.

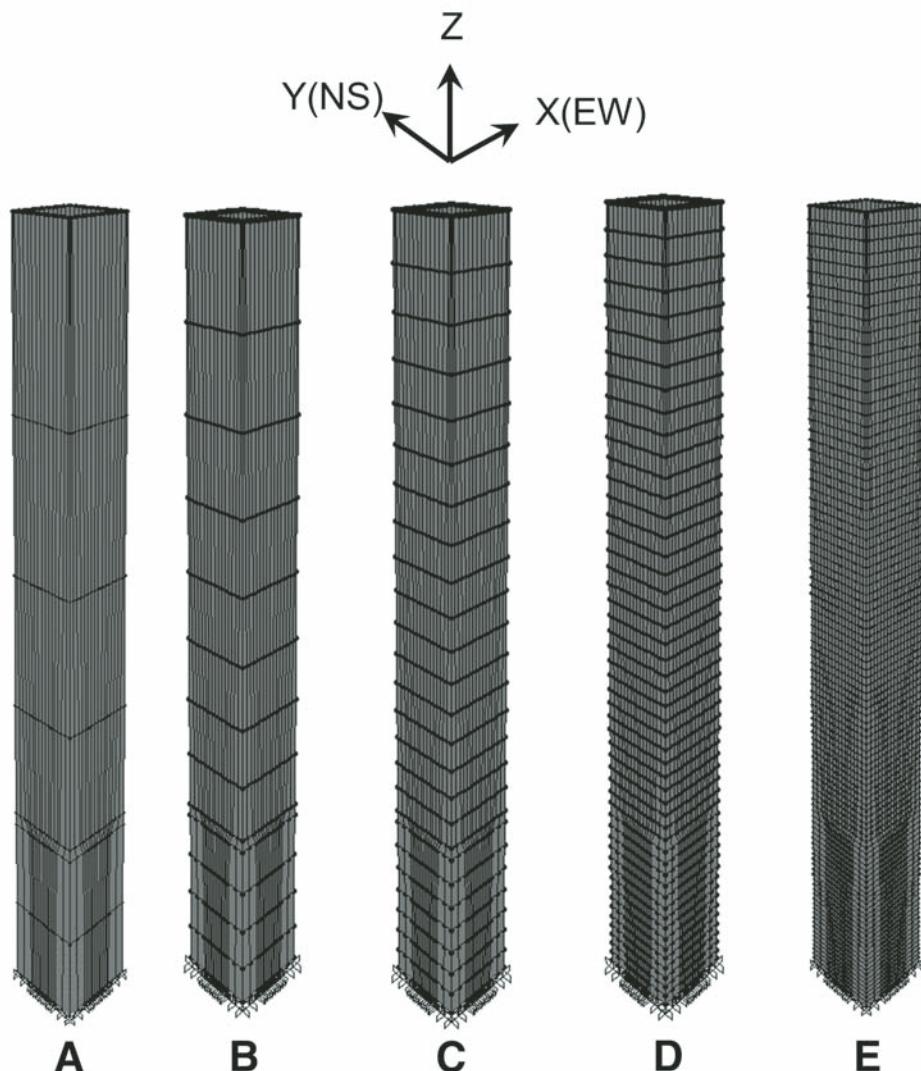
The FEM of the masonry shaft was constructed using 3D solid elements. In order to ensure the accuracy of the model, different meshes were developed by increasing the number of elements in each model (shown in Fig. 6). Among these, the FEM with 5600 solid elements (shown in Fig. 6D) was chosen since using a finer mesh of elements would change the natural frequencies of the model <0.1%. Phoenix columns were modeled with beam elements defined with pipe section properties. In order to include the effects of the stairs and platforms, diaphragm constraints are assigned to the inner nodes of the shaft at each 3.05 m level.

Figure 6. Finite element models of the Washington Monument masonry shaft. (A) 784 solid elements. (B) 1456 solid elements. (C) 2800 solid elements. (D) 5600 solid elements. (E) 11,200 solid elements.

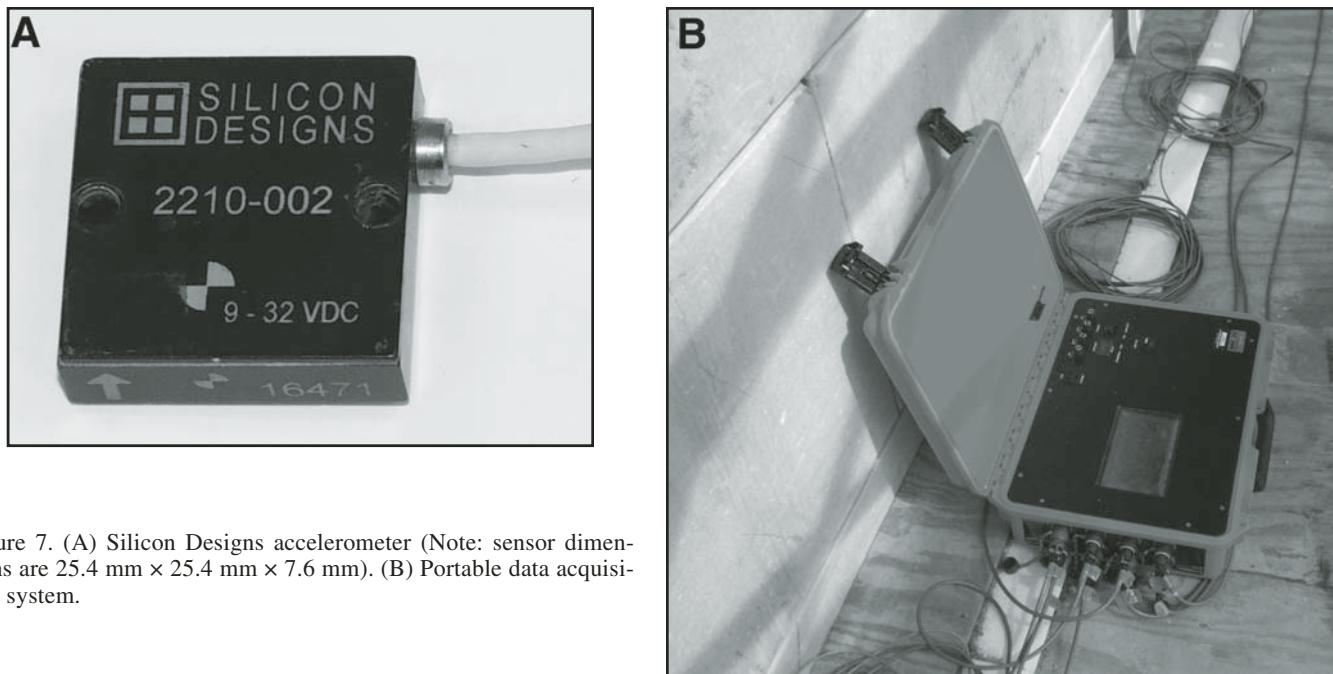
Figure 7. (A) Silicon Designs accelerometer (Note: sensor dimensions are 25.4 mm × 25.4 mm × 7.6 mm). (B) Portable data acquisition system.

Ambient vibration measurement of the WAMO was conducted using a network of eight sensors and a portable data acquisition system (shown in Fig. 7). The sensors are single-channel accelerometers manufactured by Silicon Designs, Inc. (model 2210–002; <http://www.silicondesigns.com/ds/ds2210.html>). The data acquisition system has a 24-bit analog to digital convertor, with a quantization resolution of $<1\text{ }\mu\text{g}$. The sensors have a characteristic noise floor of $13\text{ }\mu\text{g}/\text{Hz}$, which for a signal filtered at 15 Hz translates to $\sim 50\text{ }\mu\text{g}$ root mean squared (RMS) noise.

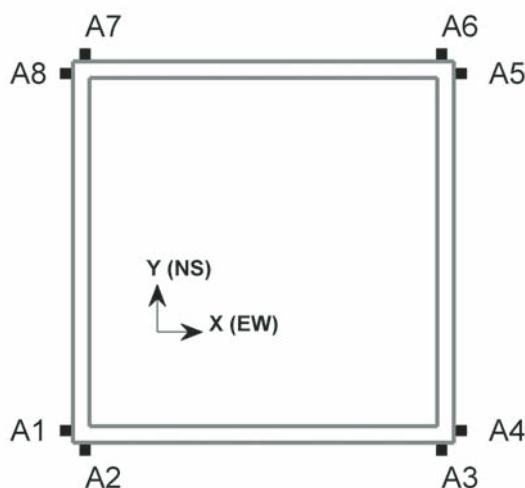
sure the horizontal vibration of the structure in two orthogonal transverse directions. Figure 8 shows the layout of this sensor network and Figure 9 shows sensors A1, A2, A3 and A4 attached to the monument. Ambient vibrations were measured for over a 60 min duration using a sampling frequency of 200 Hz (720,000 samples/channel).

Figure 8. Layout of deployed sensor network (A1–A8; level 149.7 m).

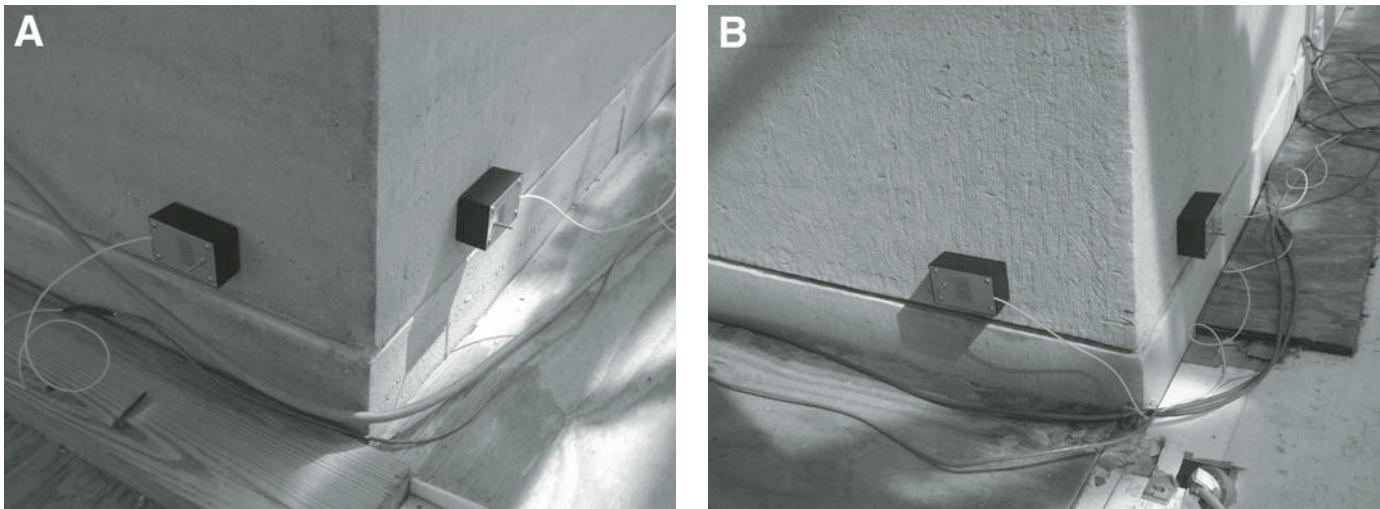
Two wired accelerometers were located at each corner of the masonry shaft of the WAMO at the 149.7 m level to mea-

Figure 9. Single channel wired sensors A1 through A4 at 491 ft. (149.7 m) level; (A) A1 and A2 located at south-west corner, (B) A3-A4 located at south-east corner.

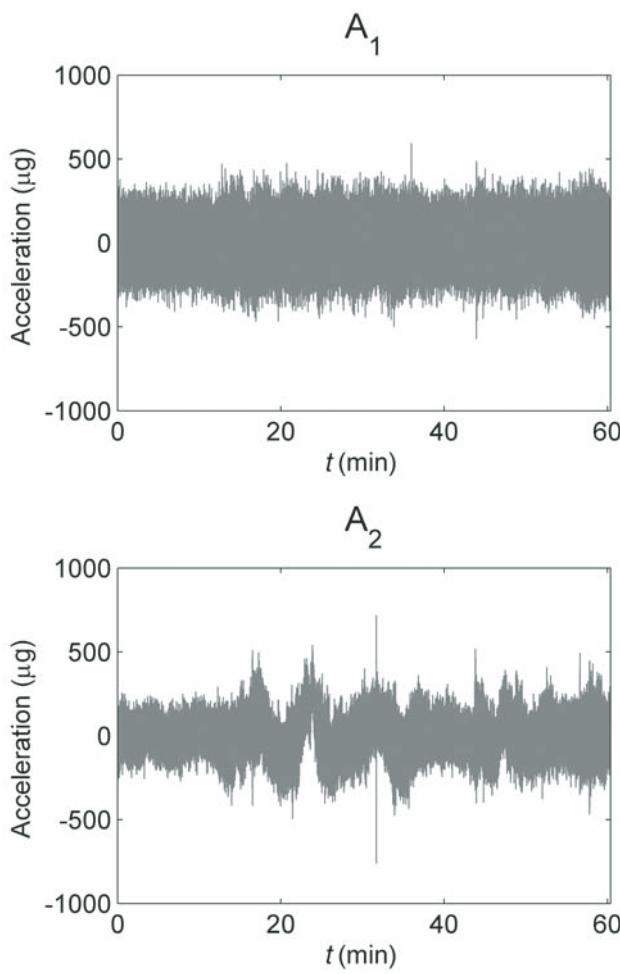
Figure 10 shows the time history of the data collected at the southwest corner of the WAMO after removing the unwanted trend due to temperature change caused by wind and sunshine. This figure shows that the ambient vibration amplitude is $\sim 300\text{ }\mu\text{g}$. The collected data are further studied in the frequency domain. Figure 11 presents the average power spectral density of the eight measured signals obtained using the Welch (1967) method. This figure shows distinct peaks of the power spectral density, corresponding to the natural vibration frequencies of the system. The peaks are distinct and clear, and repeat in data from all sensors.

Figure 10. Collected data through sensors A1 and A2 (after de-trending); t is time.

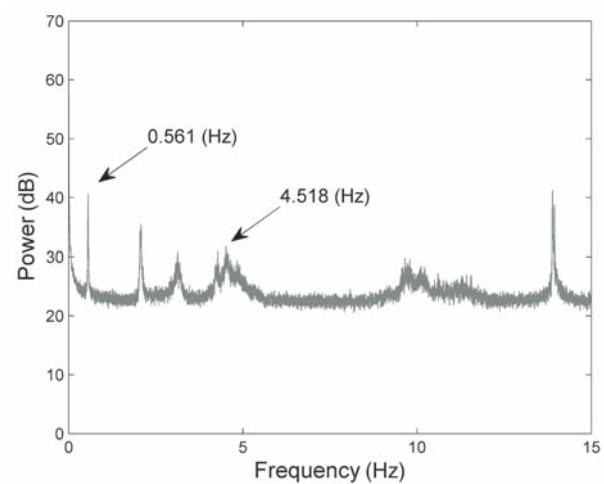
Figure 11. Average power spectral density of the collected data.

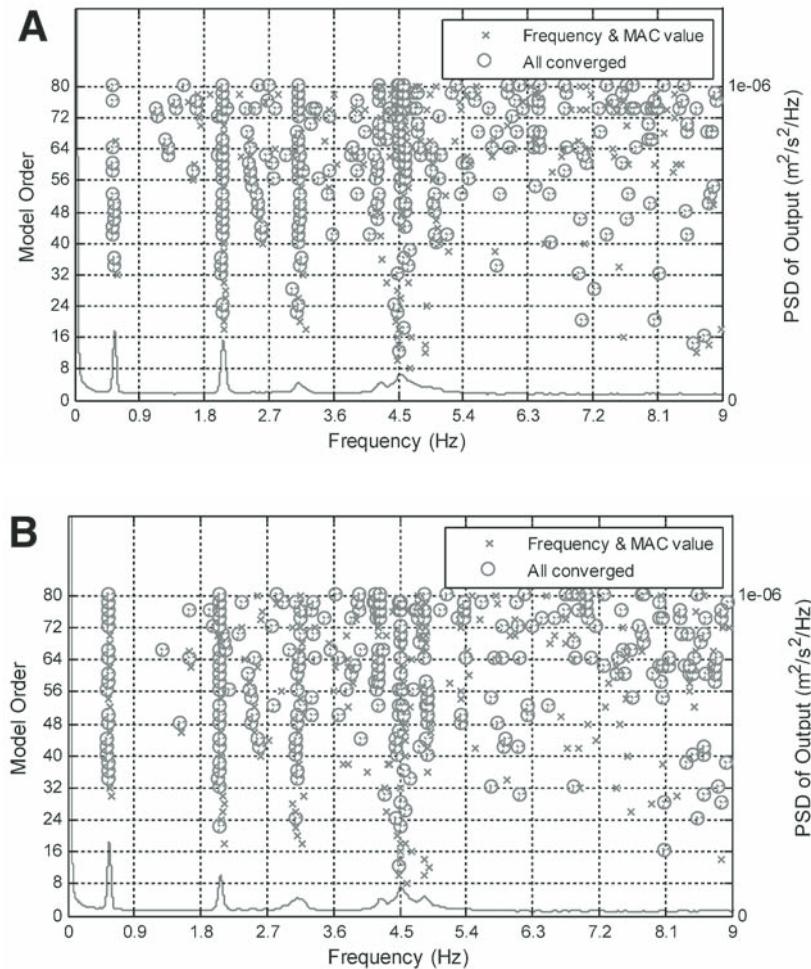
the east-west and north-south directions. In these plots, the identified modal parameters at every model order are marked if they fall within the prespecified stability threshold of the identified modal parameters at the previous model order.

Figure 12. Stabilization diagrams in 0–9 Hz frequency range based on the acceleration signals. PSD—power spectral density; MAC—modal assurance criterion. (A) Measured in east-west (X) direction. (B) Measured in north-south (Y) direction.

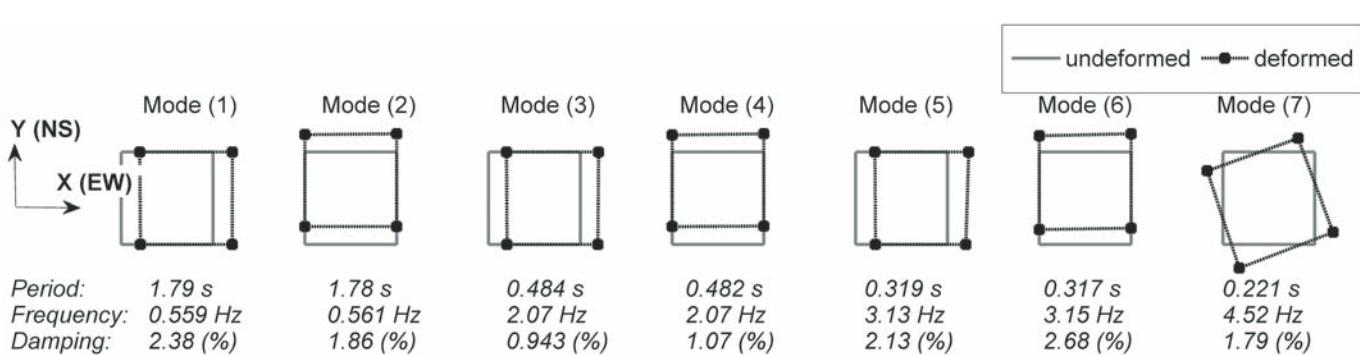
Figure 13 shows the first seven identified structural modes using the entire data set. Because the sensor deployment was located at only one level of the WAMO, no spatial information along the height of the structure for the mode shapes is available, and thus the modal ordinates are used to distinguish between modes in the two transverse directions and twisting (i.e., torsional modes). Moreover, since in this project a short-term ambient vibration analysis was conducted, a study of the effect of environmental factors on the dynamic characteristics of the WAMO was not of primary focus.

Figure 13. Experimentally identified structural modes, cross section of the Washington Monument at 149.7 m level.

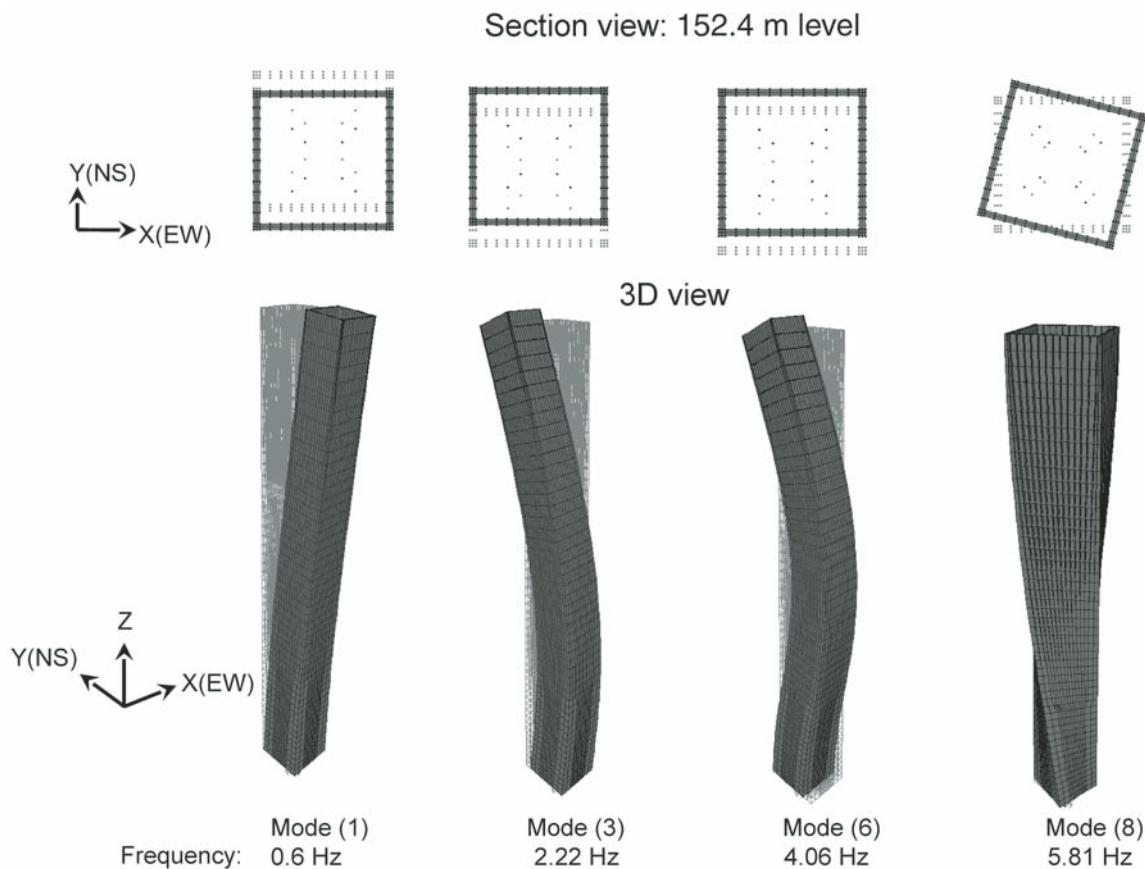
In this case, the foundation is included in the FEM, and the lower bound values for the material properties of the superstructure and the stiffness of the substructure are used. Figure 14 illustrates four analytically identified vibrational modes of the structure in case 6: first-three translational modes in the Y-direction, along with the 8th mode (torsional deformation). Translational modes in the X-direction are not pictured here; in these modes the structure

Figure 14. Analytical structural modes (case 6; see text). 3D—three dimensional.

vibrates at the same frequency and similar shape as those shown in Figure 14, but in the X-direction.

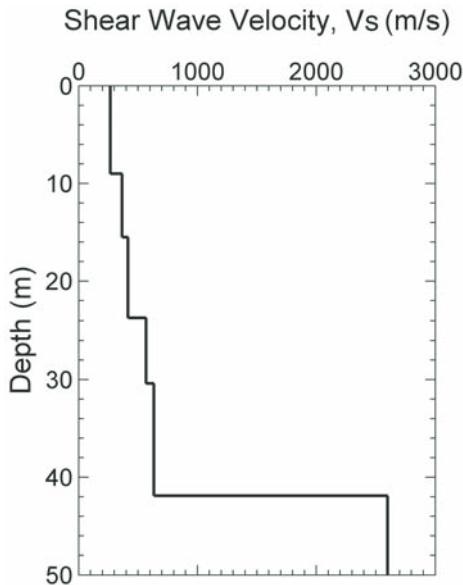
The shear-wave velocity (V_s) profile at the Reston recording station site is shown in Figure 16. Rock with $V_s = 2600$ m/s is encountered at a relatively shallow depth at this site; located at a depth of 42 m. The bidirectional (east-west and north-south) ground motions recorded at the Reston station were rotated into

Figure 16. Shear-wave velocity (Vs) profile at Reston, Virginia, recording station.

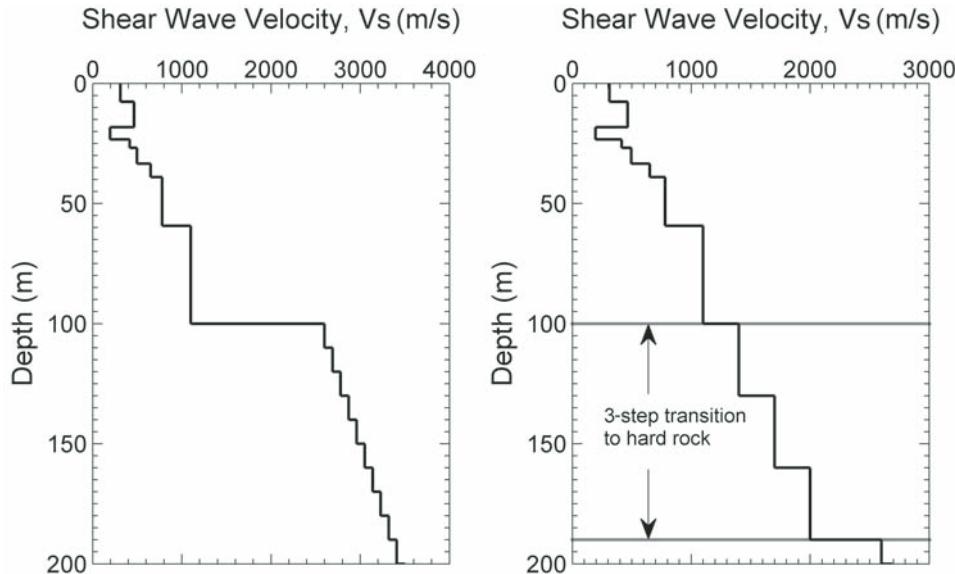
path-parallel and path-normal components along the source-to-recording site orientation (Mineral-Reston). These components at the ground surface were then deconvoluted to hard rock level ($V_s = 3500$ m/s) at Reston using the Vs profile at the station site. For Reston, it was assumed that this $V_s = 3500$ m/s material corresponding to the hard rock motions was located at a depth of 550 m with a transition from 42 m depth.

Figure 17. Shear-wave velocity (Vs) profile at the Washington Monument site used in the ground-motion response analyses considering two different transition scenarios for deeper rock levels. (A) No transition. (B) Three-step transition.

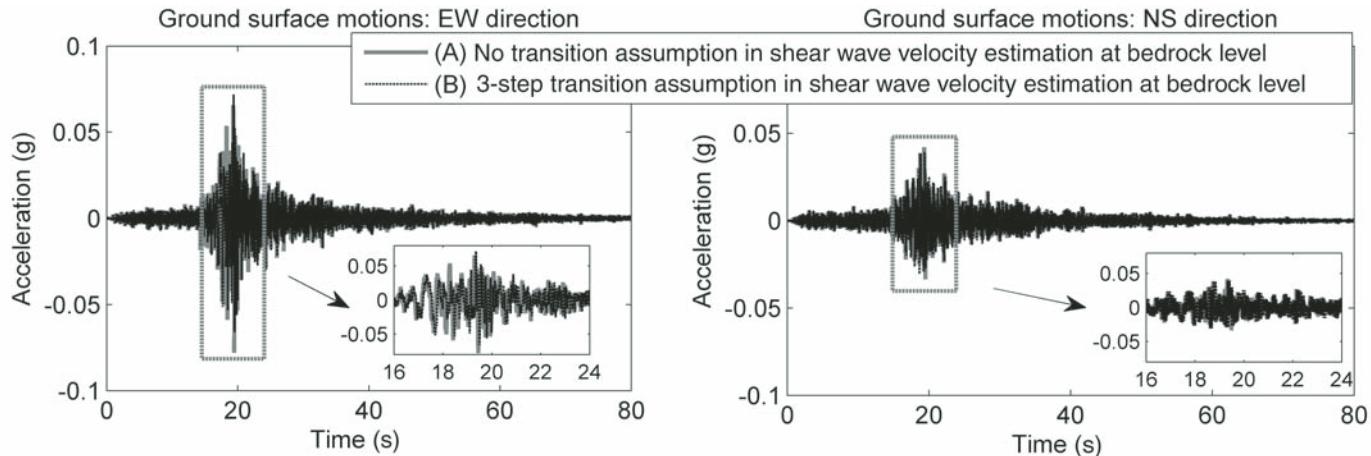
Angular transformation was used to rotate the estimated ground surface motions into east-west and north-south directions to be applied to the FEM of the system at the foundation level. Figure 19 shows these ground motions, which have 0.078 g and 0.042 g PGA, in east-west and north-south directions, respectively.

Figure 19. Estimated ground motions at the Washington Monument site during the Virginia earthquake (EW, NS—east-west and north-south components).

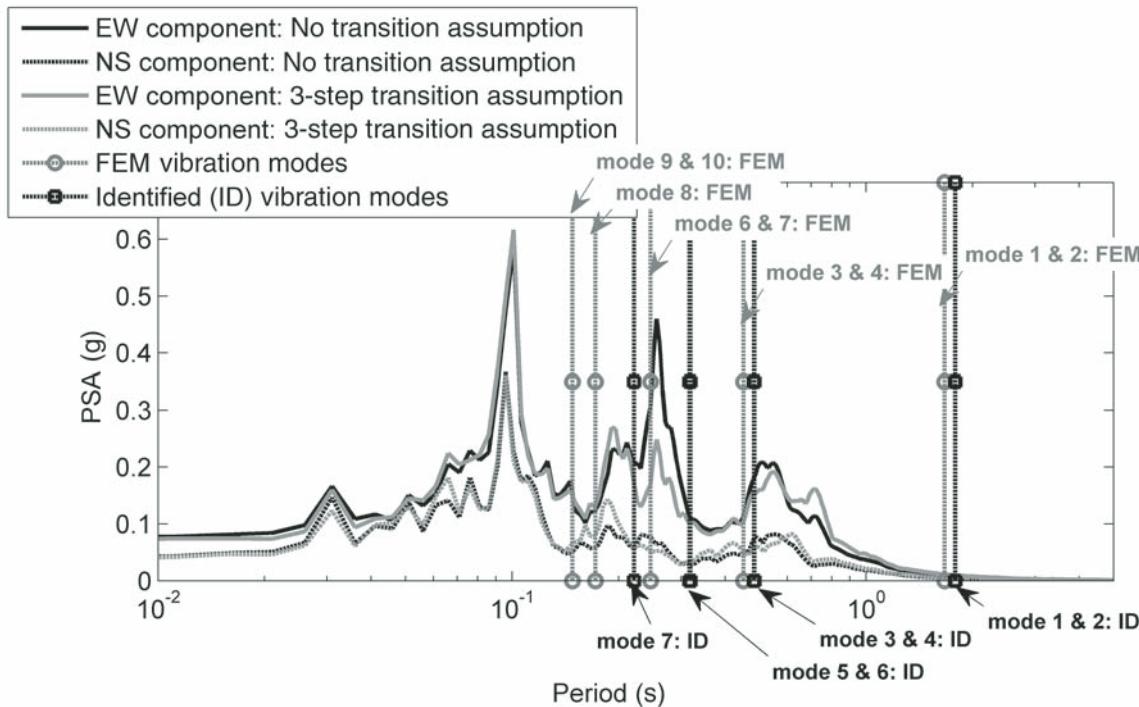
Here we present the response spectrum analyses conducted on the estimated surface ground motions. Figure 20 show the 2% damped linear response spectra for the east-west and north-south directions of the ground shaking at the WAMO site (in terms of the pseudo-spectral acceleration), along with the FEM and measured ambient structural vibration periods. Figure 20 shows that the spectrum amplitudes (for both the east-west and north-south directions) of the records generated as scenarios A and B at the natural frequencies of the structure are close in pseudo-spectral acceleration value. In addition, the response amplitude at the first and second mode periods (1.79 s) is small, while the higher modes (modes 3, 4, 5, and 6) are in a region of larger spectral acceleration amplitude. Because contribution of each vibrational mode in the seismic performance of the structure also depends on the modal participation ratios, the mass participation of vibra-

Figure 20. Linear response spectra of the east-west and north-south (EW, NS) components of the Virginia earthquake estimated at the Washington Monument site. FEM—finite element model; PSA—pseudo-spectral acceleration (see text).

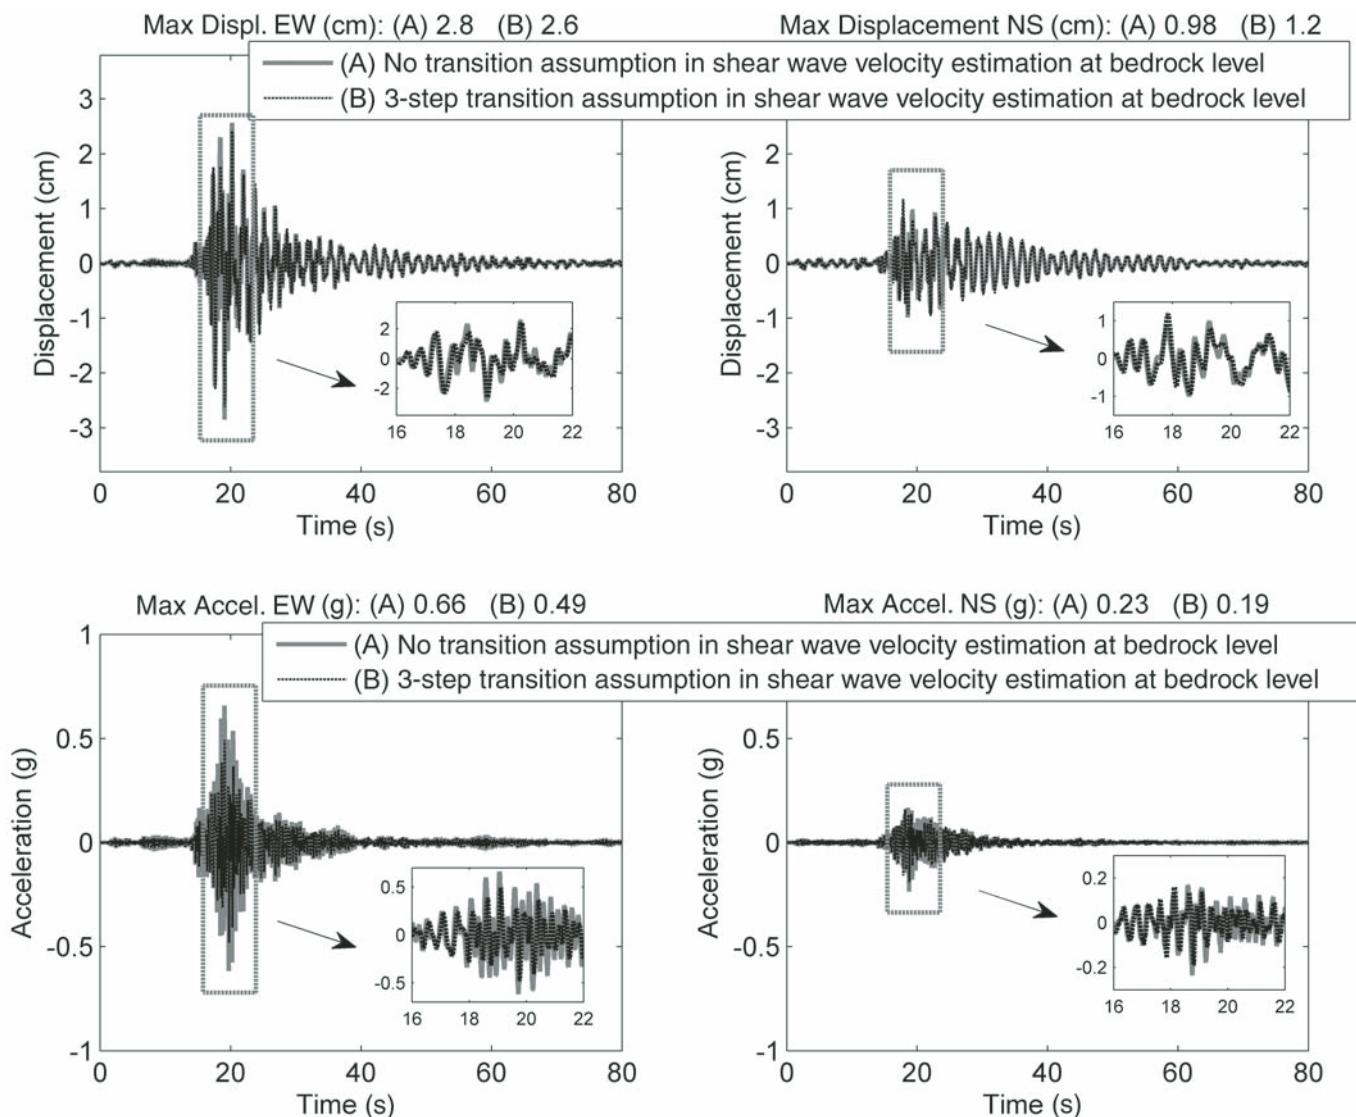
bidirectionally to the base of the calibrated FEM in case 6. Linear modal time-history analyses were performed using a time step of 0.005 s and zero initial conditions. In this analysis, a damping ratio of 2% was used for the structure, in the range of the damping ratios obtained through the structural identification we undertook (shown in Fig. 13), and consistent with the identified damping ratios of masonry structures reported in the literature (De Sortis et al., 2005; Gentile and Saisi, 2007). Figure 21 shows the time histories of displacement and acceleration during the ground shaking at the observation level (152.4 m) of the WAMO, along with their peak values. Due to the structural characteristics of the Washington Monument, the acceleration at

observation level is amplified by more than 8 and 5 times compared to the accelerations at the ground level in east-west and north-south directions, respectively. This high level of acceleration amplification can lead to the observed damage at the upper sections of the shaft, pyramidion, and fallen debris at the observation level. Figure 22 illustrates the distribution of the maximum tensile stresses (in the vertical Z-direction) on the outer surface due to the combined effect of the structure's weight and bidirectional ground motions over the entire history of the earthquake record. The color scale on the bottom of Figure 22 indicates the magnitude of the stresses; the highest tensile stresses are shown in dark gray and white represents zero tensile stress. The tensile stresses show a high concentration around the 107 m level. However, these tensile stresses are significantly smaller than the reported tensile strength of masonry stone. Based on the ASTM (formerly the American Society for Testing and Materials) specifications (Standards C503/C503M-10 and C615/C615M-11; ASTM, 2010a, 2011) moduli of rupture of marble and granite are 6.9 MPa and 10.3 MPa, respectively. Maximum compressive stress throughout the structure (-3.69 MPa) is also considerably smaller than the reported compressive strength of marble (-52 MPa), granite (-131 MPa), and grout (-13.8 MPa). Compressive strength of the grout was estimated based on ASTM specifications (Standard C476-10; ASTM, 2010b), and tensile strength of the grout was assumed to be ~10% of its compressive strength. Therefore, the concentration of the maximum tensile stresses (as shown in Fig. 22) could explain the cracking

Figure 21. Structural response of the Washington Monument at 152.4 m level. Max Displ.—maximum displacement; Max Accel.—maximum acceleration; EW, NS—east-west, north-south.

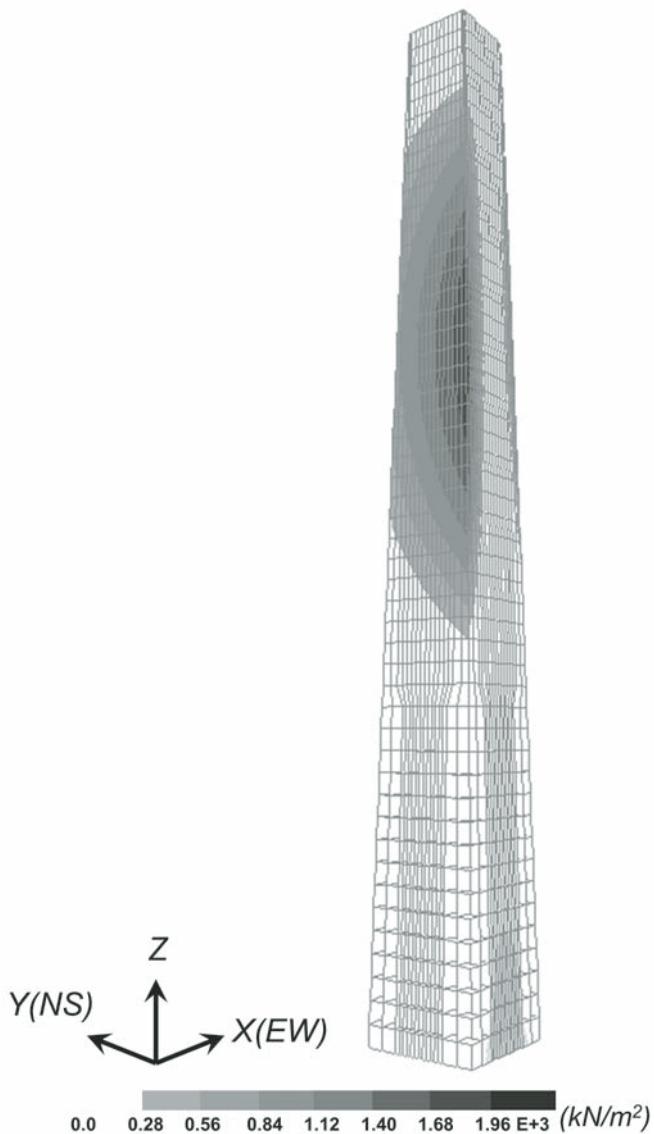
damage at this location of the masonry shaft of the WAMO in terms of the mortar loss and re-cracking observed in the previously repaired cracks.

Figure 22. Envelope of the maximum tensile stresses in the vertical direction, Washington Monument. No transition assumed in shear-wave velocity estimation. EW, NS—east-west, north-south.
