Damage reconnaissance and seismic response prediction of an East Coast U.S. building subjected to 2011 Virginia Earthquake

During the 2011 Mineral, Virginia Earthquake the Smithsonian Institute Museum Support Center (MSC) sustained considerable structural damage. An in-depth study was conducted to investigate the behavior of MSC during this earthquake and its potential implication on seismic risk of East Coast U.S. structures. The damage sustained by this building is documented and it is observed that the severity of damage is not uniformly distributed in the floor plan. A finite element model is created to perform the seismic response prediction using recorded ground motions in order to explain the cause of structural damage. A field vibration test was conducted to capture the dynamic characteristics of the building which are in turn used to calibrate the finite element model. Results from seismic analysis reveal that the main reason for seismic damage is local soil amplification and combined torsional and translational effects due to an eccentric floor mass distribution relative to the center of rigidity (CR) of the floor plan.

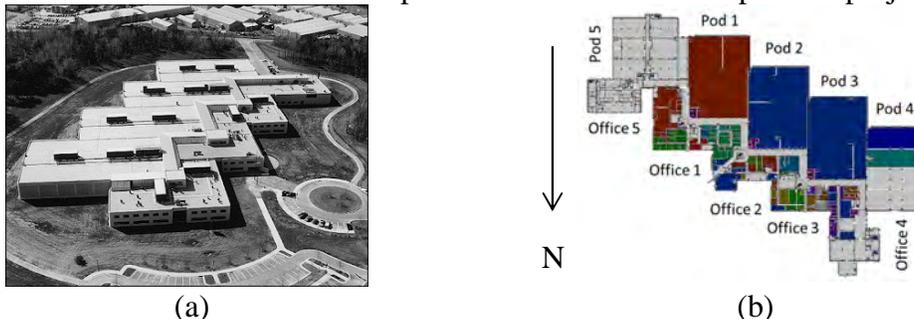
Figure 1. (a) Aerial view of MSC in 1980s (without Pod 5 and Offices 5) (www.mnh.si.edu); (b) Floor plan of MSC

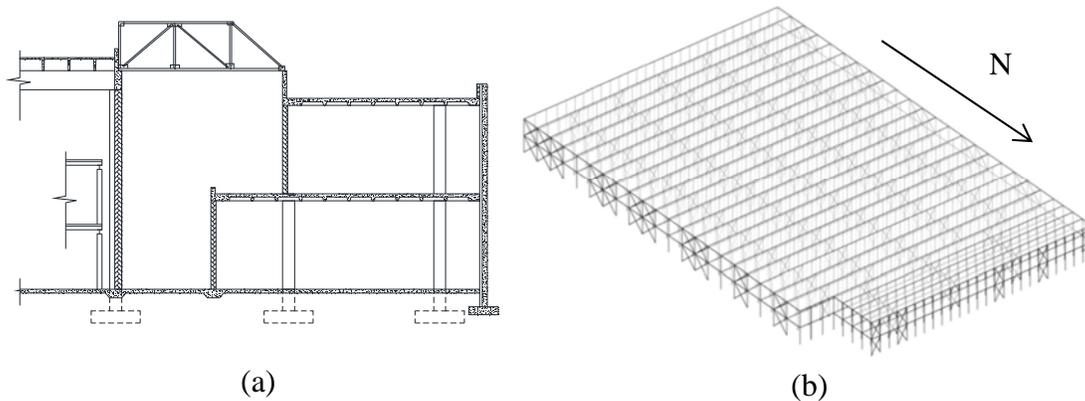
Figure 2. (a) Typical elevation of Pod, Offices and mezzanine; (b) Steel mezzanine inside Pod

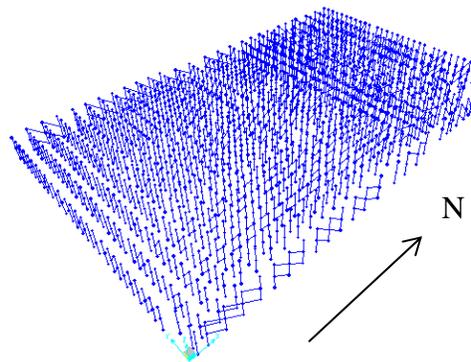
Figure 5. Isometric view of SAP2000 FEA model of steel mezzanine

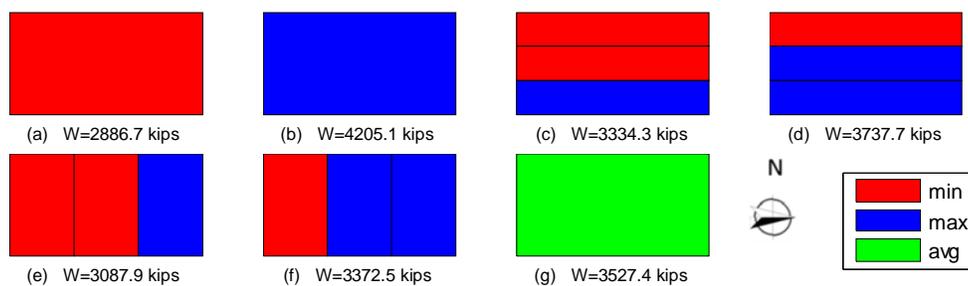
As there are more than 1000 cabinets on each floor, it will be prohibitively difficult to vary the weight of every cabinet to study the effect of content weight on the location of the floor mass. So instead, seven extreme representative cases of mass distribution are considered, and are shown in the floor plan provided in Figure 6. In Cases I, II and VII, all the cabinets have minimum, maximum and average content weight distributed uniformly over the floor plan of both floors, respectively. In Cases III and IV, the floor plan is trisected along its short direction (EW direction), with all the cabinets within each subarea having the same mass distribution. For example, in Case III, all the cabinets in the 2/3rds of the floor plan towards the east direction have the minimum mass while those in the lower 1/3 of the floor plan in the west direction have maximum mass. In Case V and VI, the floor plan is trisected along its long direction (NS direction), as shown in Figure 6(e) and (f).

Figure 6. Illustration of cabinet content weight distribution and resultant total floor weight over floor plan: (a) Case I; (b) Case II; (c) Case III; (d) Case IV; (e) Case V; (f) Case VI; (g) Case VII

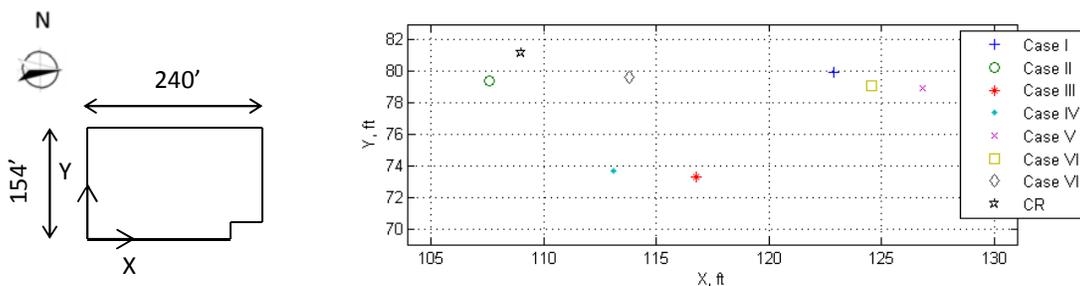
The location of the center of mass (CM) for each case of content weight and the center of rigidity (CR) are shown in Figure 7. A summary of the eccentricity between the CR and CM for each case is given in Table 2. The total floor weight and location of CM show a large variance due to a wide range of possible content weight.

Figure 7. Location of the CM within the floor plan of the mezzanine for each cabinet content weight case

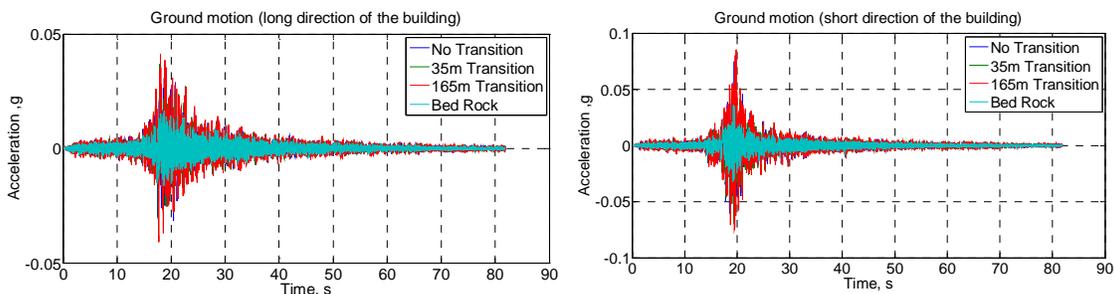
**Figure 8. Time history of generated bi-directional ground motion at MSC**

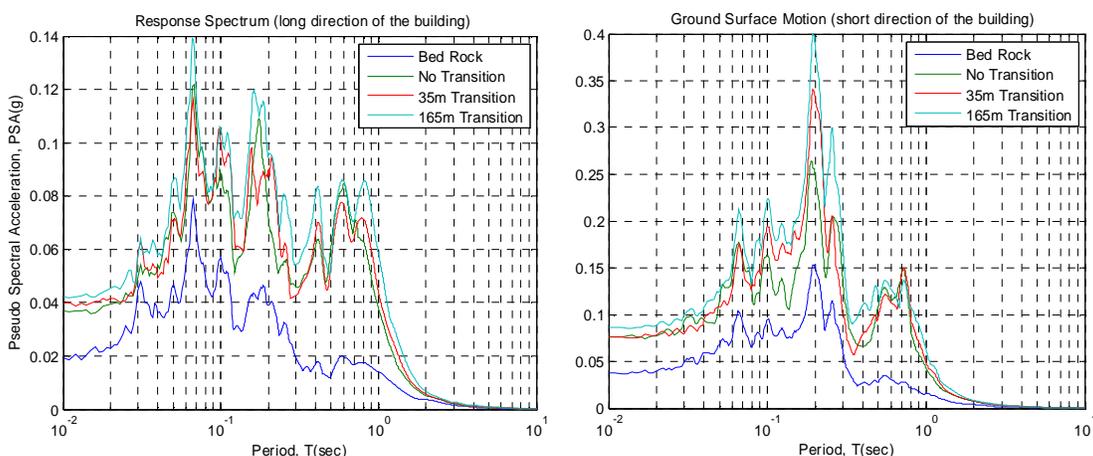
**Figure 9. Response spectrum of generated bi-directional ground motion at MSC**

The ground motion with the assumption of 165m of transition gives the largest response spectrum, and is therefore selected as the ground excitation applied to the structure in the parametric study. This study is performed by conducting time history analysis using the FE model and the above bi-directional ground motions. Different cases yield different results of seismic response. The result from Case I described in Figure 6 gives the closest agreement with the observed damage.

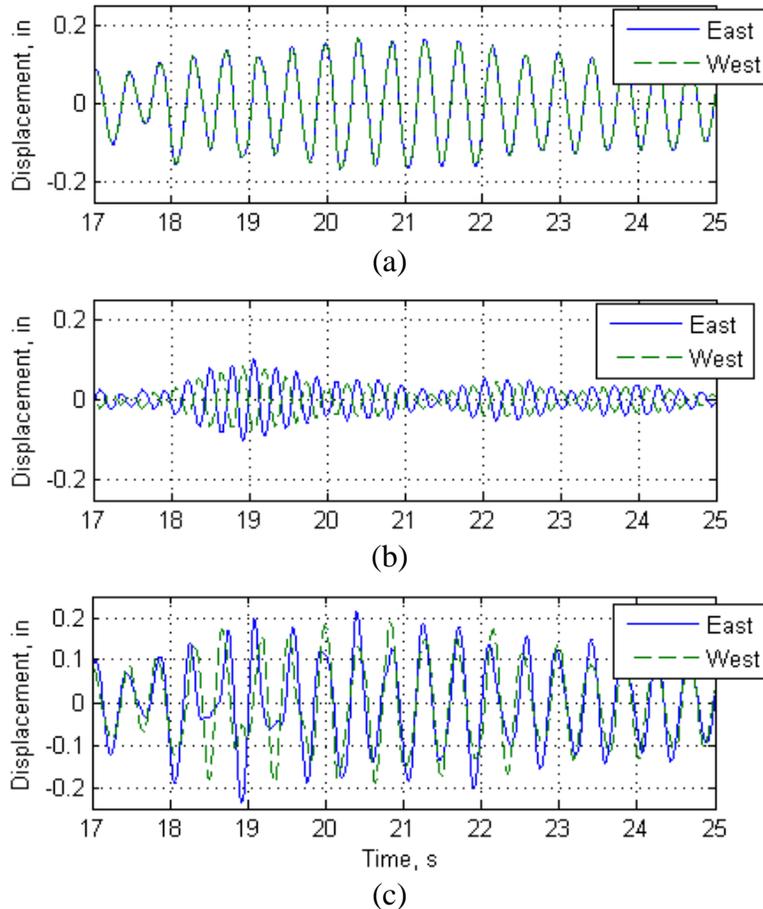
By close examination, this unique damage pattern can be attributed to significant coupling between the translational and torsional displacement of the floor diaphragm induced by bi-directional ground motion excitation. The effect of bi-directional excitation is clearly demonstrated by comparing the response of the structure under uni-directional and bi-directional ground motion. Figure 11 presents the time-history of lateral displacement in the NS direction for two braced bays located respectively at the east and west perimeter (identified within the red circles in Figure 10) under uni-directional ground motion in the NS, EW and bi-directional ground motion, respectively. When the ground motion strikes in the EW direction (i.e., short direction of the building; Figure 11(b)), the displacement demand in the NS (i.e., long direction of the building) direction is comparable to the case when the building is subjected to ground motion in the NS direction (Figure 11(a)). In addition, the non-uniform response in braces in the long direction of the building is also caused by ground motion in the short direction of the building. The reason is, in this case, the CR of the first floor deviates from the CM by 13.9' to the south and 1.2' to the east (see Table 2). Larger eccentricity in the long direction creates a significant component of torsion in the second and third modes (Figure 13). In addition, the earthquake in the short

Figure 11. Time history for translation of joints at the top of columns in east and west perimeters: (a) response to ground motion in NS direction; (b) response to ground motion in EW direction; (c) response to bi-directional ground motion

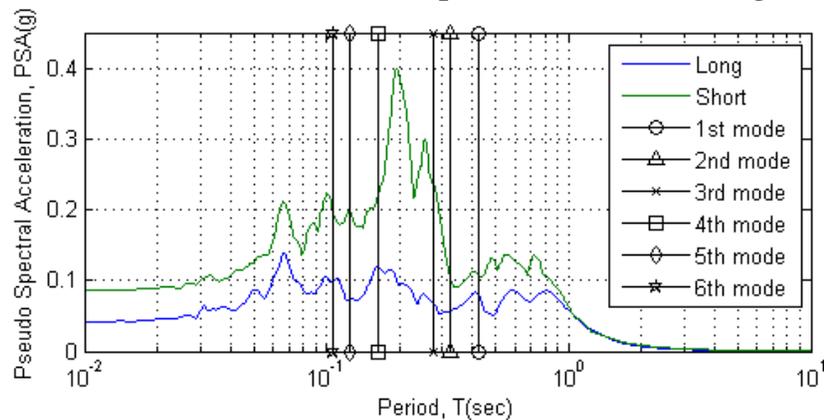
direction has much larger magnitude than its perpendicular component, especially at the second and third modes due to the effect of soil amplification (Figure 12). Consequently, the torsional component from the second and third modes in response to the ground motion in the short direction will impose extra and non-uniform demand on the displacement response in the long direction.

Figure 12 Response spectra of two components of ground motion and structural periods

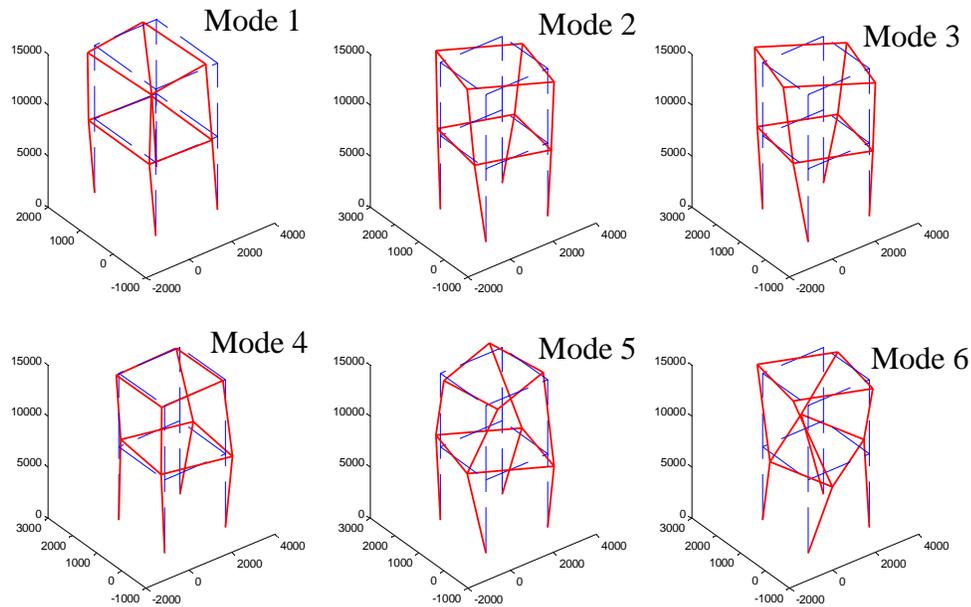
Figure 13 Mode shape of Case I model
